November 1984

***Denali Mine On Valdez
Creek, South Central Alaska:
A Cultural Resources Evaluation***

by Beth E. Walton

Bureau of Land Management
Alaska

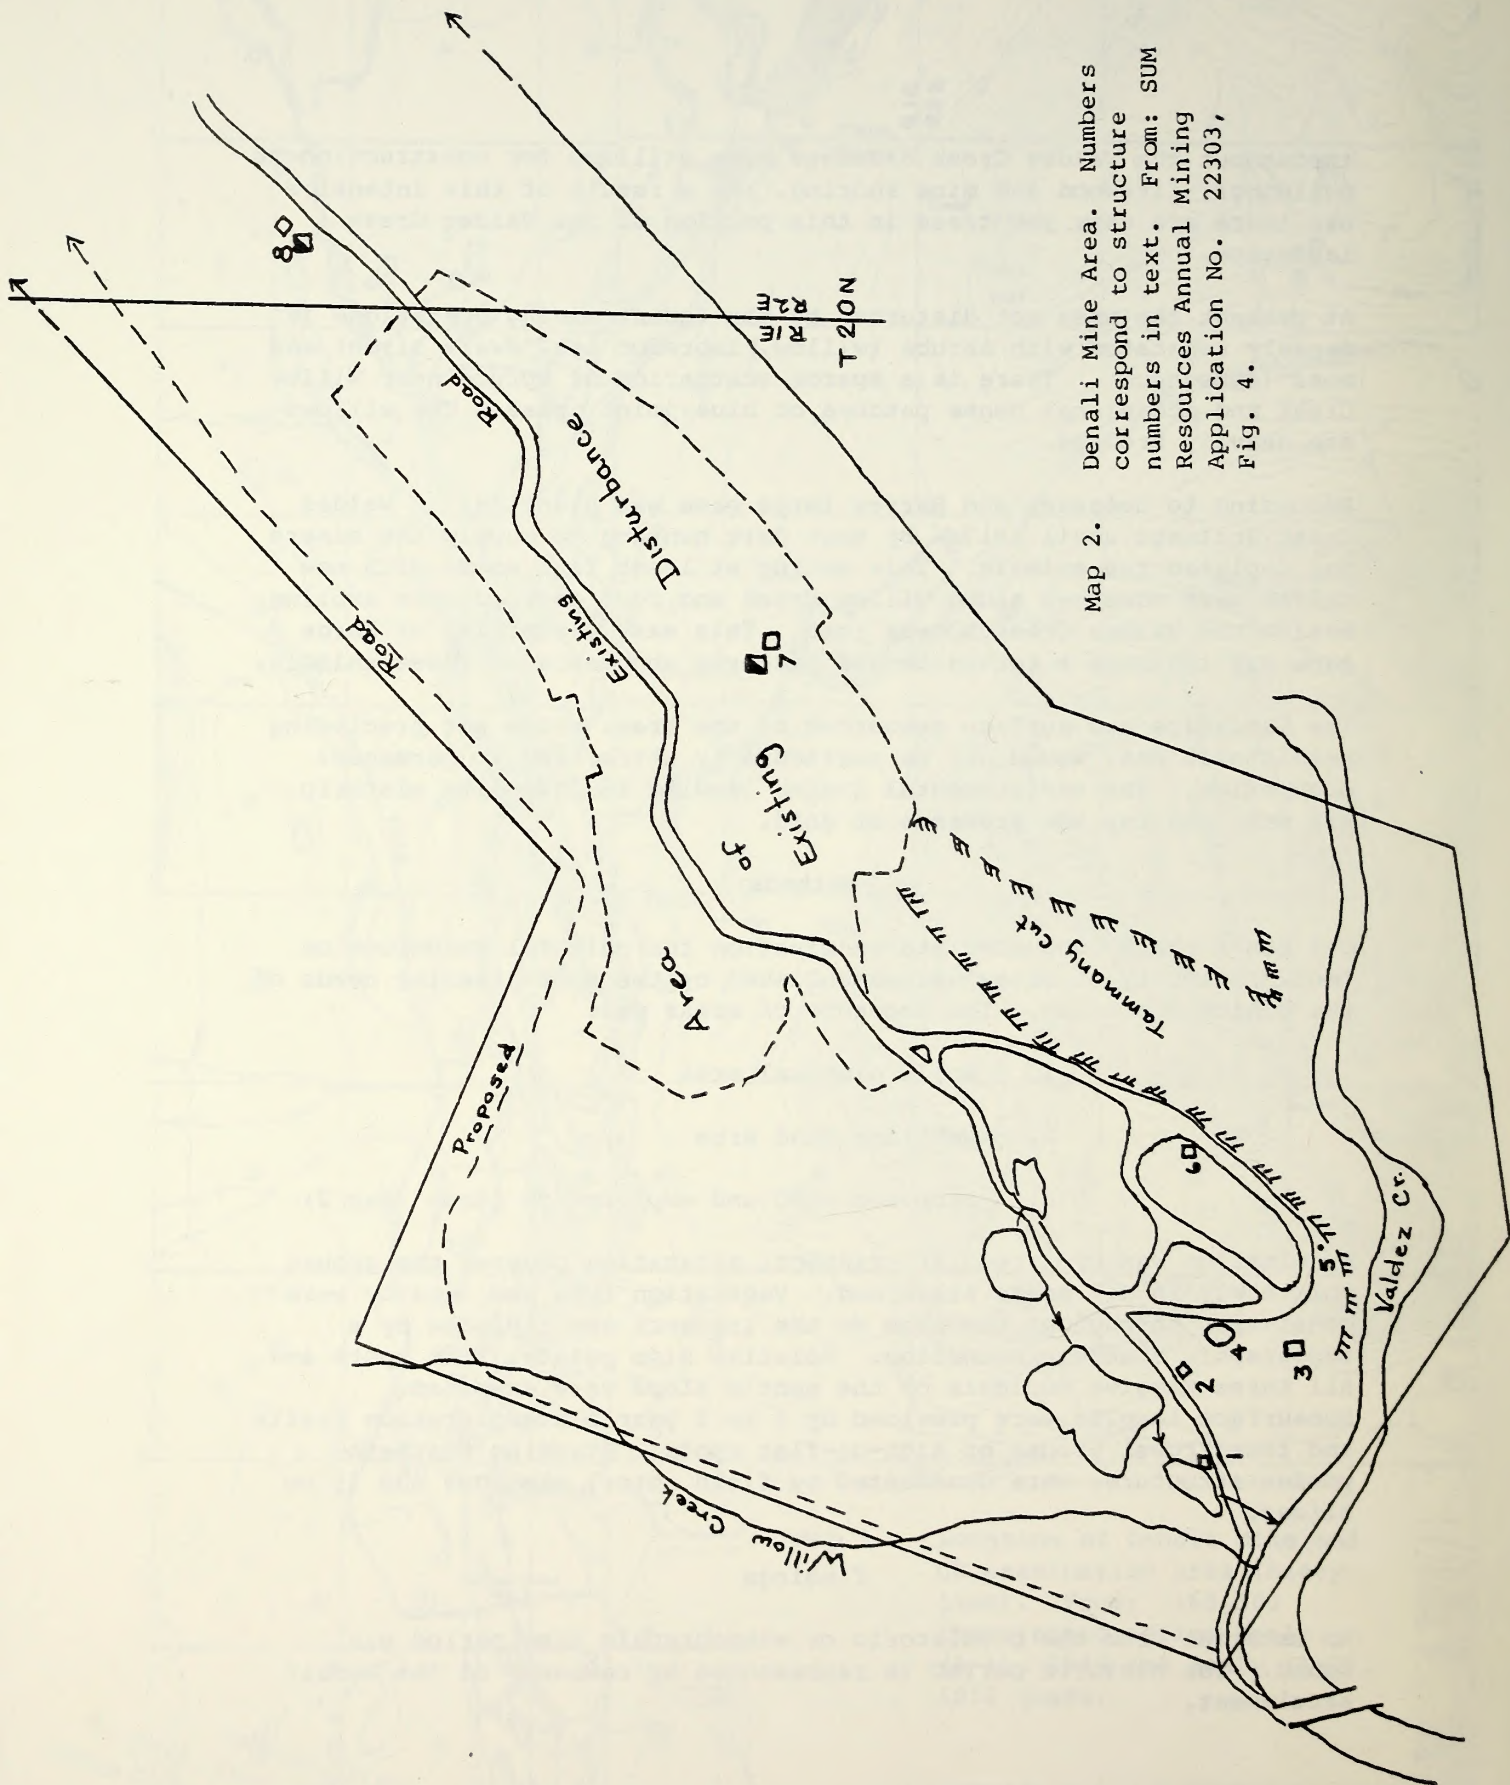
Map 2. Denali Mine Area. Numbers correspond to structure numbers in text. From: SUM Resources Annual Mining Application No. 22303, Fig. 4.

- 1 Cabin ruin: logs, trash, broken bottles, broken china and a wood stove. The structure is completely destroyed.
- 2 Dog kennels: four simple sloped roof structures remain. All are in poor (unusable) condition.
- 3 Graves: white picket fences about 8' long, 5' wide and 4' high surround each of two graves. Both graves are in good condition. Fences are made of 4x4 corners and 2x4 rails with 4x1/4 pickets. The east grave is identified by a horizontal, bronze(?) plaque (approximately 12" x 8") that reads

- 4 Sled dump: The remains of sleds used to haul in supplies are primarily of running gear; no beds were observed. Tundra vegetation has obscured many pieces. There are likely more than ten and fewer than thirty pieces.
- 5 Three-hole Privy: This 9' x 6' shiplap plank structure is still in occasional use. The roof is gabled and there are 1 x 8" cornercaps. The interior has two partitions for semiprivity of multiple occupants.
- 6 Superintendent's house: The roof and east wall of this three-room log cabin have fallen in. Dessauer and Harvey (1980: 89, 98-99) noted that this structure was partially collapsed in 1977. Observations in 1984 are at variance with the details given in their 1980 report, particularly in the floor plan (compare Fig. 1, p. 4 with Dessauer and Harvey, Fig. 5).

- 7 Shack at Shaft No 1: This single room structure is 14' x 10'. The entry is in the west side of the south wall as is one 3/3 casement window. The exterior saltbox shape is modified to a gabled ceiling on the interior. The exterior planks were covered by tar paper and battened. The roof is corrugated tin. The three board door is locked with a new looking padlock.

- 8 Shack at Shaft No 3: This board and batten one room structure measures 10'x10'. The entry is in the middle of the south wall. There is a 2/2 sliding casement window slightly south of center in the west wall. The interior has a table on the west wall and an open overhead rack in the northeast corner.

Based on the plan of operation and discussion with the mine operator, the operations will not disturb the graves, kennels, sled dump, superintendent's house, or privy. The cabin ruin between the access road and proposed settling pond #4 may be disturbed or may sluff down; since this structure is ruined, further disturbance is inconsequential. The shack at Shaft No. 1 may be disturbed in overburden removal. The shack at Shaft No. 3 is not in this year's plan area but may be disturbed in a future year. Although in good condition, these structures lack association with to the historic (1903-1930) period or with known persons and their disturbance would be inconsequential. Measurements taken in this survey will serve to document their structural characteristics.

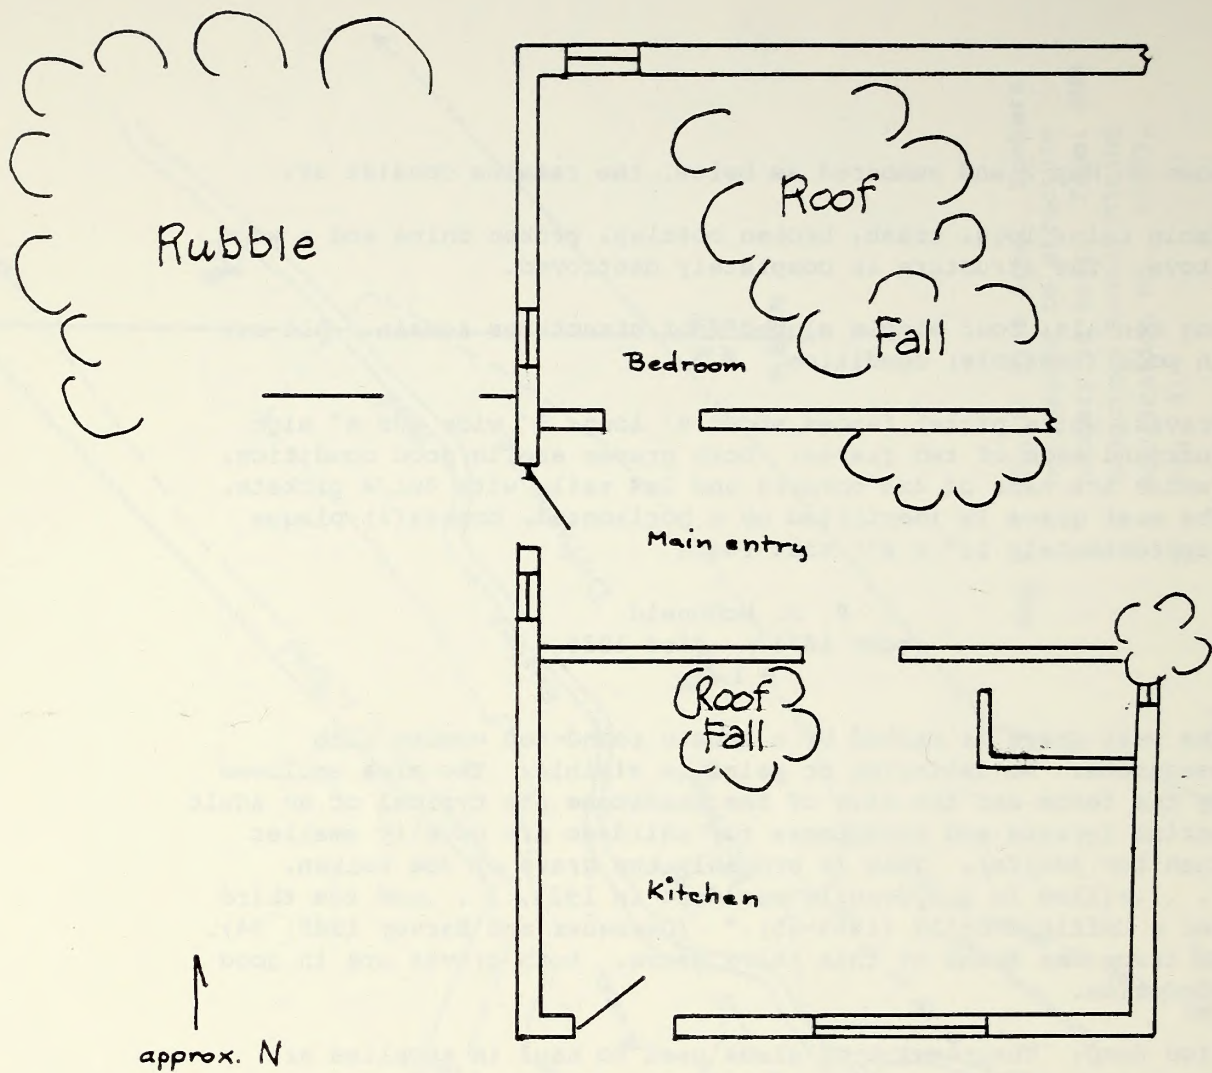
Fig. 1. Superintendent's House

The main entry, a four horizontal over two vertical panel door, is nearly centered in the west wall of the structure. A second (kitchen) entry is in the south wall. This door is Z-braced, patterned tongue-and-groove (Fig. 2). There is one long 4/4 fixed window in the south wall. In the west, there is a 2/2 window beside the main entry door and a 2/2 window near the south corner of the bedroom. The standing remnant of the east wall has a small 2/2 window. The north wall has a 2/2 window near the west corner. All these windows are double hung. All remaining exterior frames are simple 1x6 casement painted a deep amber yellow.

Interior: Exterior logs were smoothed on the interior side. The interior floor space (Fig. 1) was divided into three rooms and a small walk-in pantry. Walls and ceiling were covered with canvas tarps. This, in turn, was overlain with patterned oilcloth on some ceilings and, at least in the main entry area, a wainscot of brown burlap. Windows and doorways had cornice treatments (Fig. 2).
